U.S. ARMY ABERDEEN TEST CENTER

ATEC PROJECT NO. 2006-DT-ATC-MK2RB-D2477  
TEST RECORD NO. WF-E-83

## ***Jet Propellant (JP)-8 Fuel Evaluation Test***

### ***Mk II - Reset (Mk II R) Bridge Erection Boat (BEB)***

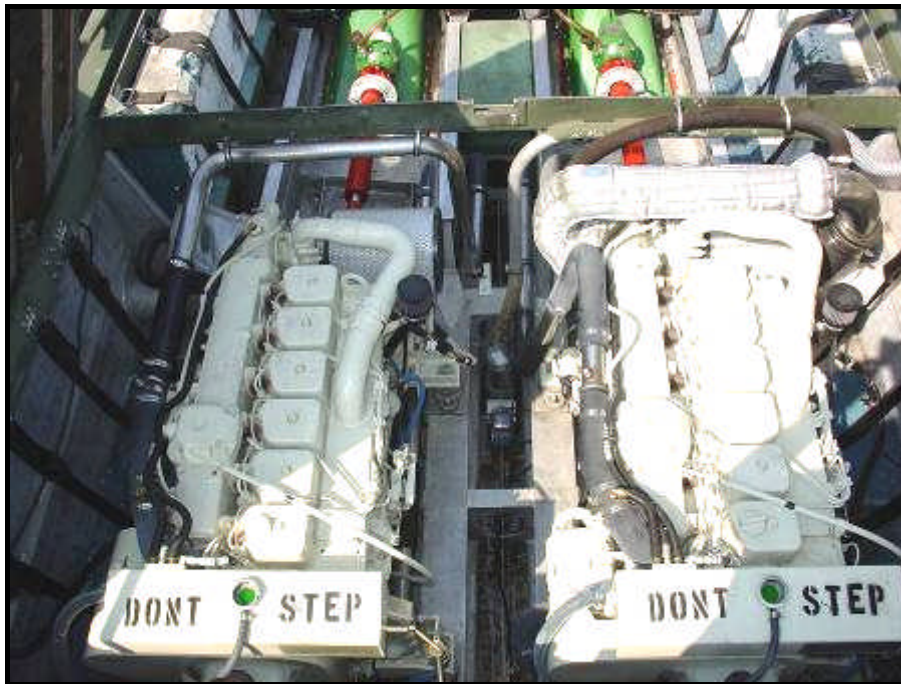
Figure 2. Mk II R, twin Cummins 6BT 5.9-L engines during initial inspection.
